**Examination of Spray-Applied Oxsilan 9810/2 Steel
Pretreatment on a Mine Resistant Ambush Protected
(MRAP) Vehicle**

ARL-TN-578

October 2013

Jack Kelley and Tom Braswell
Weapons and Materials Research Directorate, ARL

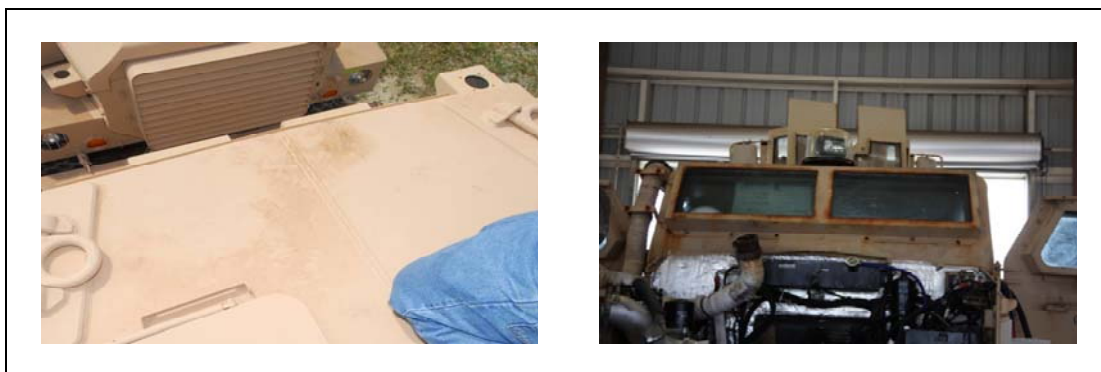
The high-hard armor (HHA) steels that are used for Mine Resistant Ambush Protected (MRAP) vehicles, and a wide range of other systems, provide good protection against armor piercing threats. However, without good corrosion protective coatings these steels corrode rapidly. Photos of newly fabricated, unfielded MRAP vehicles showing significant corrosion have circulated within the Department of Defense (DOD) community. While some may dismiss this rusting as merely cosmetic corrosion, the reality is that such corrosion on military ground vehicles increases the infrared signal from the vehicle that the topcoat camouflage usually inhibits, making the vehicle more vulnerable to detection by the enemy.

Figure 1. Two examples of CARC-coated MRAPs with pretreatment step omitted.

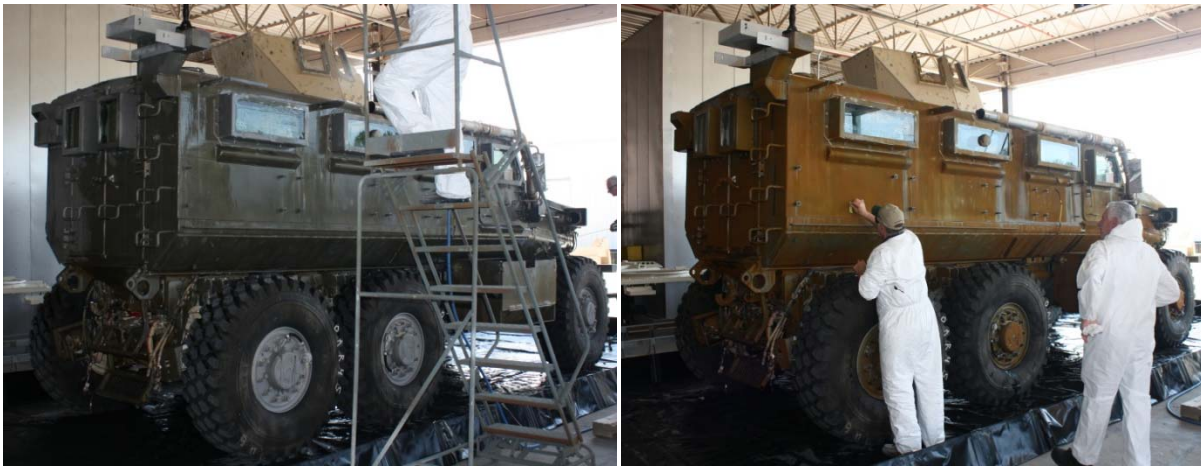
Figure 5 shows MRAP No.1 during and after the application of the Oxasilan 9810/2. These results were completely unexpected and bear no resemblance to the surface finish that was achieved on earlier test panels or the Stryker hatches treated at ANAD.

Figure 5. MRAP No.1 during application of Oxasilan 9810/2 pretreatment (left), and after application with the Oxasilan 9810/2 RTU from drums June 10, 2011 (right).

During a conference call meeting with Chemetall America's Product Manager on the evening of June 20, several possibilities for the unexpected results were discussed: (1) improper solution chemistry (2) application rate (not enough flow) (3) surface contamination because MRAP No.1 was abrasive-blasted 72 h prior to treatment, and/or blast media was contaminated. A sample of the Oxasilan 9810/2 was taken from the drums and sent to the Chemetall Laboratories for analysis. Chemetall Laboratory determined that the solution chemistry was within their acceptable range. As a result, further tests by ARL were conducted to attempt to duplicate the

The results of the ARL HHA test panel experiments indicate that the unusual MRAP result was caused by multiple factors. The brownish-red color of the MRAP was most likely the product of both surface contamination, and insufficient flow and rinsing of the Oxsilan 9810/2. The surface may have been first contaminated by the blast media, which may have contained soluble salts, and/or by the bare freshly blasted steel being exposed to the uncontrolled environment near the Atlantic Ocean at Camp Lejeune, NC (figure 10) for 72 h. Ionogenic contamination from abrasives is transferred uniformly onto steel surfaces. This can turn the steel surface a homogeneous light-gray-to-black color, depending on the concentration (11). The trucks were light-gray with no noticeable corrosion before treatment. But once the pretreatment was applied (using insufficient flow rate in this case), the reaction produced a corrosion-like color on the vehicle. Laboratory tests also indicate that it is possible for optimum flow of the Oxsilan 9810/2 to perhaps compensate for the contamination by essentially washing away the contaminants quickly enough to allow the Oxsilan 9810/2 organo-silane polymers to react with the cleaned metal, leaving a clean-gray finish behind. In addition to the panel testing, evidence of the advantage of the greater flow rate can be seen in the MRAP picture in figure 11. The light-gray streaks occurred at locations where there was a higher flow rate of Oxsilan 9810/2 (i.e., continuously running down the side).

The results indicate that a combination of events contributed to the corrosion-like appearance of the MRAP. With the upscale from laboratory sized and smaller hatch-sized parts to full-sized parts, the scope of the MRAP was underestimated, resulting in inadequate flow of the applied Oxsilan 9810/2. We also believe that the 72 h the bare surface of the vehicle was exposed to the environment led to some surface contamination, which likely would affect the reaction of the Oxsilan 9810/2 with the steel surface. We cannot rule out the possibility that the grit used for abrasive-blasting the vehicles may have contained chlorides or other salts that would have also served to contaminate the steel surface. The laboratory tests and the previous demonstration of Strykers indicate that the Oxsilan 9810/2 must be applied to a freshly clean abrasive-blasted surface as soon as practical, preferably within 2–4 h of abrasive-blasting. The flow rate used for the Oxsilan 9810/2 should be sufficient enough to keep the vehicle wet throughout the treatment. Rinsing with clean water should be done, again using adequate flow rate to thoroughly remove the unreacted Oxsilan 9810/2. We are confident that the desired results can be achieved by following these recommendations.

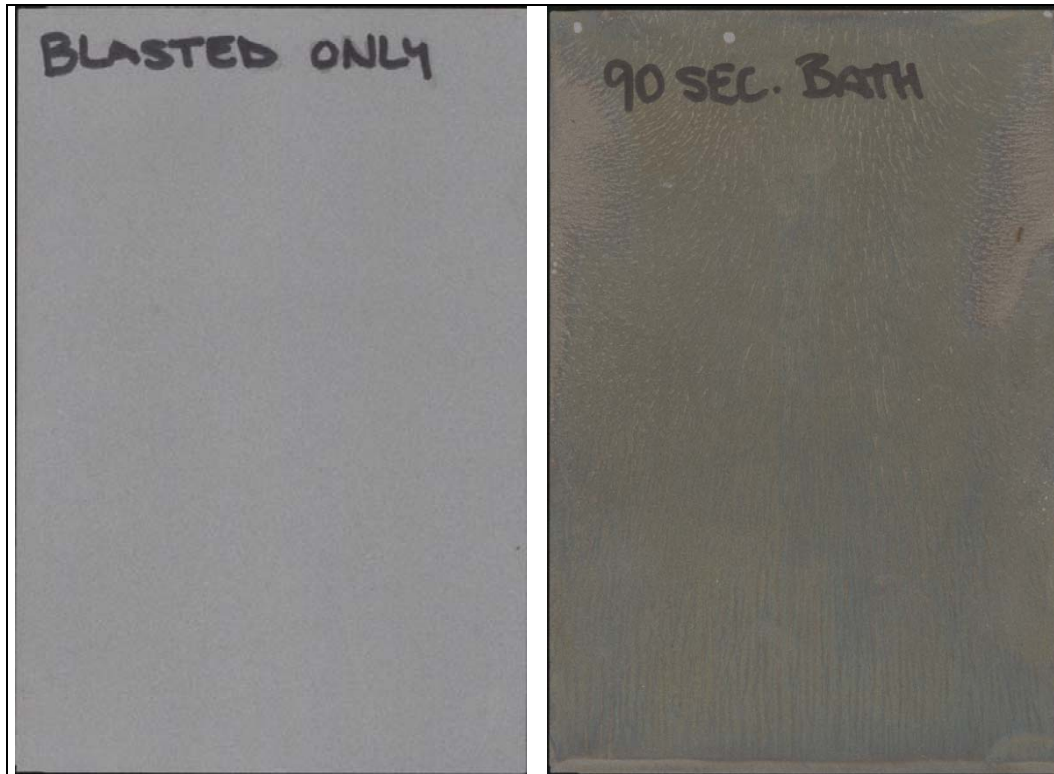
Panels sprayed with maximum flow and maximum dwell time showed a color change. In this case, the colors of the panels were uneven and blotchy with streaks of orange, pink, gold, blue, and dark gray. Figure 6 shows two contrasting panels. On the left is a freshly abrasive-blasted

HHa panel with no pretreatment. A noticeable color change was evident and did not resemble the color seen in either the MRAP demonstration, the samples discussed earlier in the previous laboratory validation, or that of the Stryker demonstration.

Figure 6. A freshly abrasive-blasted, untreated HHA panel (left). A panel “bathed” in Oxsilan 9810/2 for 90 s dwell (right).

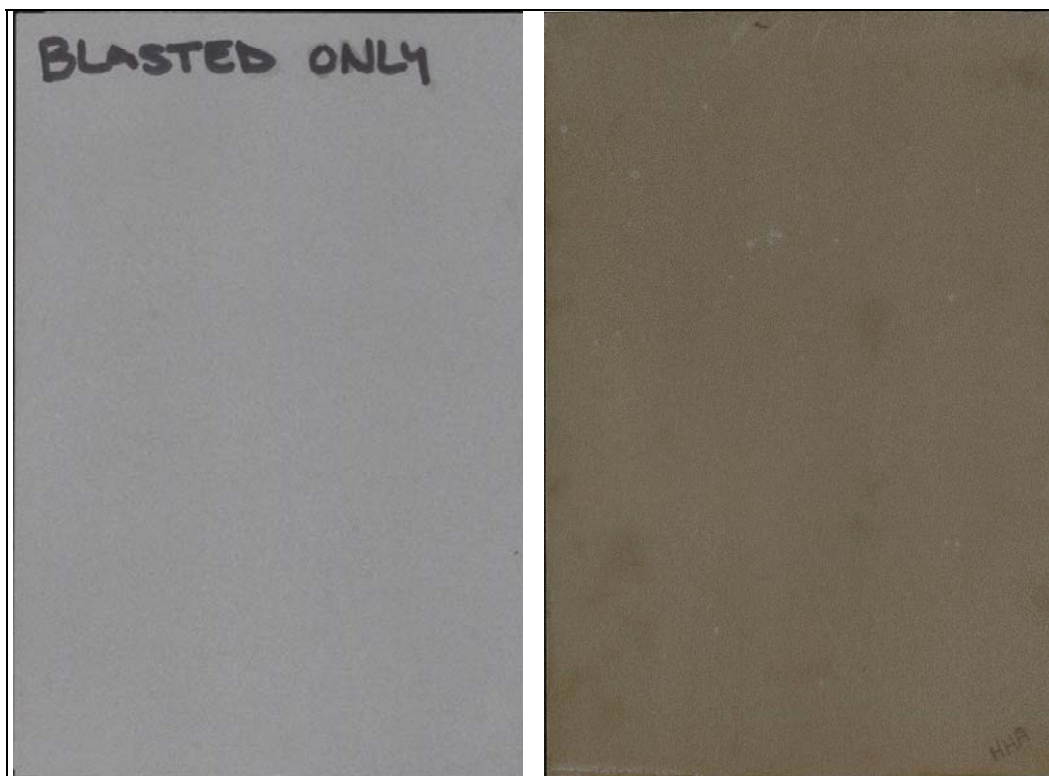
The worst-case for flow and dwell time is represented by the panel on the right in figure 7. The panel was sprayed with the minimum flow allowable to keep the panel wet for 30 s and subsequently rinsed with DI water. As seen, there is an obvious color change compared to the clean abrasive-blasted panel on the left. The panels represented by figure 7 were a bright gold. The color was relatively even, but the color change was dramatic and again did not resemble the color seen in either the MRAP demonstration, previous laboratory validation, or the Stryker demonstration.

Figure 7. A freshly abrasive-blasted, untreated HHA panel (left). A panel sprayed with Oxsilan 9810/2 for 30 s dwell (right).

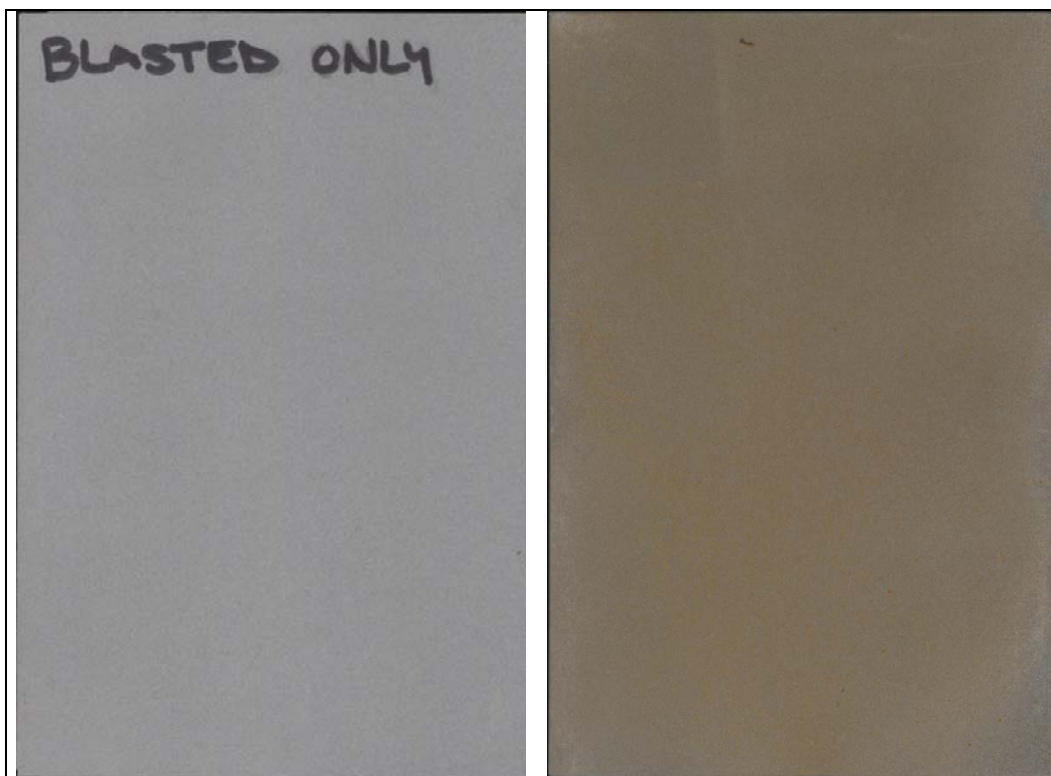
After the HHA test panels were sprayed with 3.5% NaCl solution they were allowed to dry completely. No red rust was evident at this time. These panels were subsequently spray-treated with Oxsilan 9810/2. The pretreatment was sprayed on and allowed to dwell for 90 s as recommended by the manufacturer. After the 90 s dwell, the panels were rinsed thoroughly with DI water and allowed to dry. Figure 8 shows the NaCl spray contaminated panel after the Oxsilan 9810/2 treatment in the photo on the right. The panel appeared to have an orange hue similar to the appearance of “red” rust. This color was slightly more orange in color than panels that were not contaminated with NaCl.

Figure 8. A freshly abrasive-blasted, untreated HHA panel (left). A panel first sprayed with NaCl solution, then treated with Oxsilan 9810/2 (right).

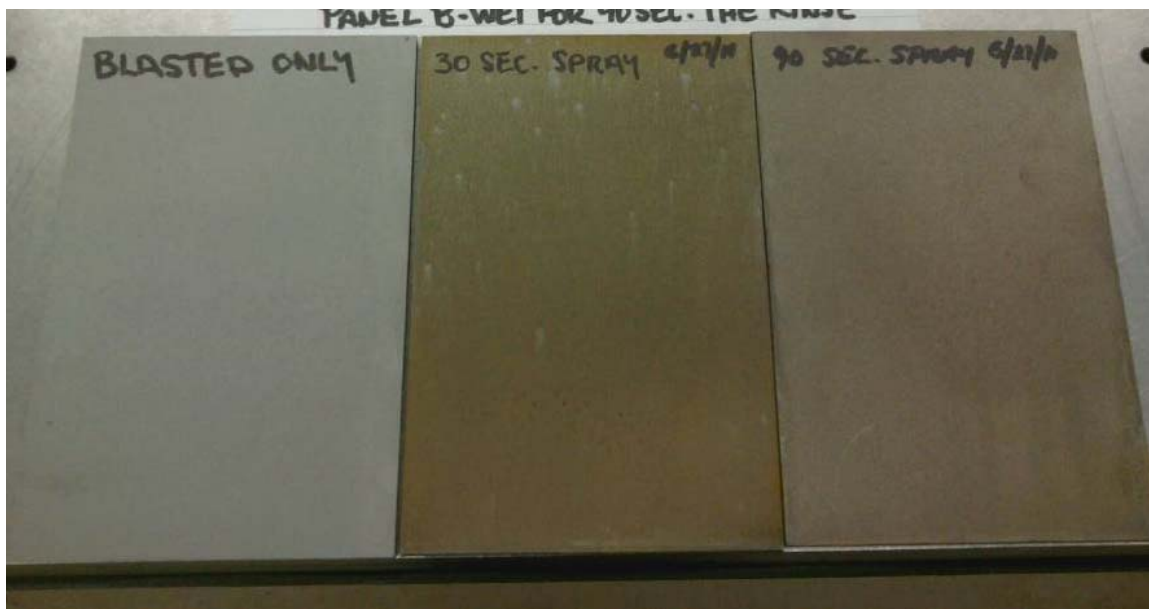
A significant change in the color was evident in these panels as seen in figure 9. The color is very similar to what was seen on the MRAP during the demonstration at Camp Lejeune. Unique to these test panels versus all of the others, was the spotting and streaking of the panel that was only allowed 30 s of dwell for the Oxsilan 9810/2; again, similar to the MRAP. The surface was clearly contaminated, and the contamination appeared to have an effect on the consistency of the ability of the Oxsilan 9810/2 to react with the steel substrate. There was also a color change with the panel treated for 90 s, but it did not resemble the MRAP results.

The color change in the 90 s dwell panel was far less dramatic. In some respects, it resembled the earlier “best-case scenario.” The results of this experiment indicated that more than one factor may have affected the MRAP results. As demonstrated, the pre-exposed panel with the lower dwell time created a similar color as the MRAP at Camp Lejeune.

Figure 9. Example of a freshly blasted HHA panel (left). The panel in the center and right were treated with Oxsilan 9810/2 following 72 h in an outside environment. The center panel was treated using minimal flow for 30 s, and the right panel was bathed for 90 s.

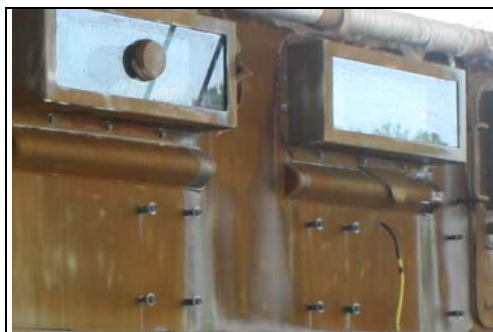
Figure 11. Gray areas along edges of windows where there appeared to be a higher flow rate of Oxsilan 9810/2.
